Prepared For: Gordon's Ltd

The following describes the findings of the inspection of the onsite wastewater treatment system at:

Inspected: 3375 Orser Rd Elginburg

Date: May 15, 2025

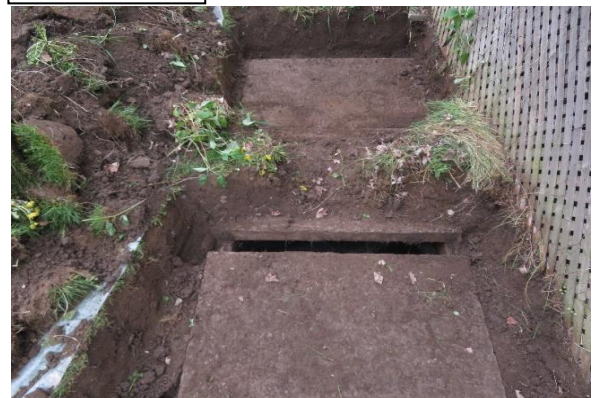
Slab top tank

- 1 The Septic tank is a slab top design which is difficult to access for servicing. Recommend improving access when possible.
- 2 Recommend the installation of an effluent filter to improve the longevity of the absorption area, however the design of the treatment tank makes instillation and servicing impractical.
- 3 The septic tank design is less than the current standard. Recommend improving when necessary.
- 4 The absorption area was evaluated by flow test only.
- 5 Flow test results may be more favourable when there has been a lack of regular use.
- 6 The onsite sewage system was functional at the time of inspection, future longevity can not be predicted.

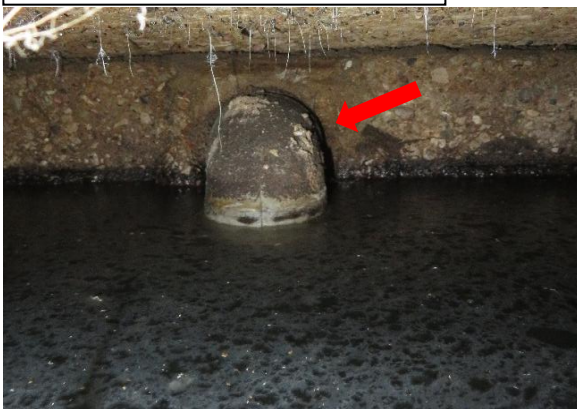
No effluent filter at outlet
