Prepared For: Gordon's Ltd

The following describes the findings of the inspection of the onsite wastewater treatment system at:

Inspected: 737 Chatterson Rd Odessa

Date: December 2, 2024

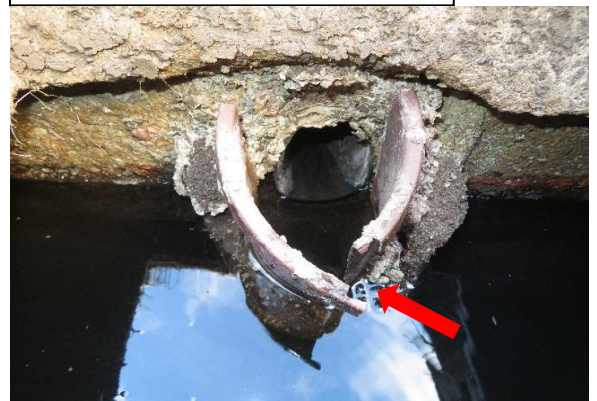
No effluent filter at damaged outlet

- 1 Recommend water filter discharge is directed away from septic system if possible, as it places an additional load on the treatment system.
- 2 Outlet baffle is damaged. Recommend repair or replacement with effluent filter assembly.
- 3 Recommend the installation of tank lid risers for ease of use when servicing.
- 4 Missing handle at outlet lid. Recommend correction to improve ease of use when servicing. Plastic was left in lieu of a handle as a temporary measure for ease of use.
- 5 The absorption area was evaluated by flow test only.
- 6 Flow test results may be more favourable when there has been a lack of regular use.
- 7 The onsite sewage system was functional at the time of inspection, future longevity can not be predicted.

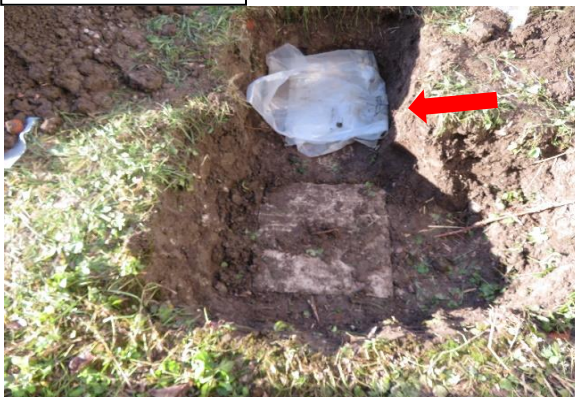
Lid missing handle

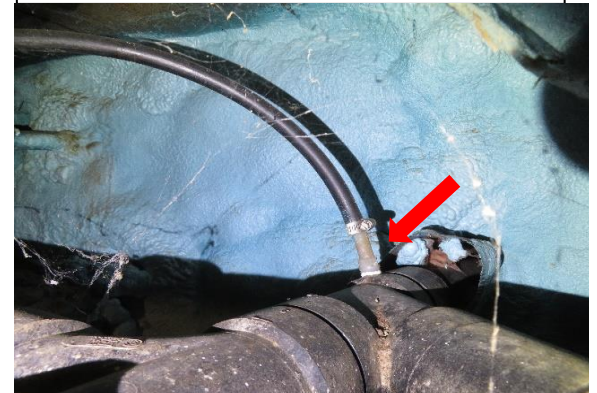
Water filter discharge to septic
