The following describes the findings of the inspection of the onsite wastewater treatment system at:

Inspected: 808 Kitley Elizabethtown Townline Rd North Agusta

Date: October 10, 2025

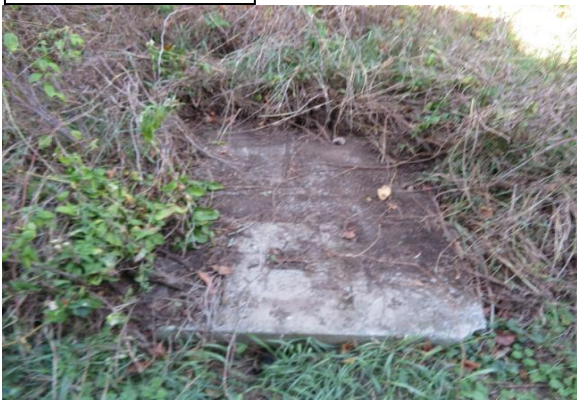
Exposed tank top

- 1 Recommend the installation of an effluent filter to improve the longevity of the absorption area.
- 2 There are sufficient accumulated solids to recommend pumping, when weather permits.
- 3 A portion of the septic tank is exposed. Recommend improving by providing ground cover or insulation to exposed portion of tank to protect against possible freezing.
- 4 Recommend providing cover at exposed drain and waste line to prevent mechanical damage.
- 5 Concrete center baffle has degraded sufficiently to recommend further evaluation and repair estimates are provided by a qualified contractor.
- 6 The absorption area was evaluated by flow test only.
- 7 Flow test results may be more favourable when there has been a lack of regular use.
- 8 The onsite sewage system was functional at the time of inspection, future longevity can not be predicted.

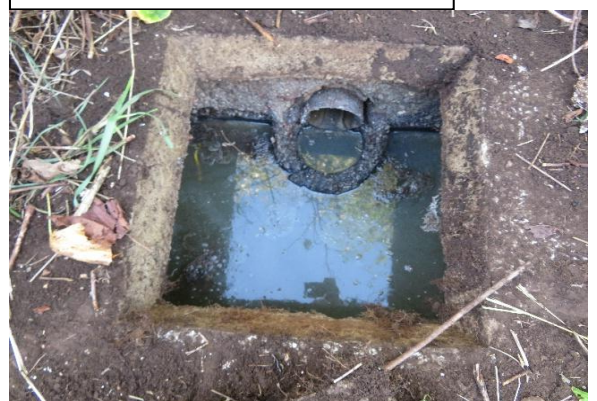
No effluent filter at outlet

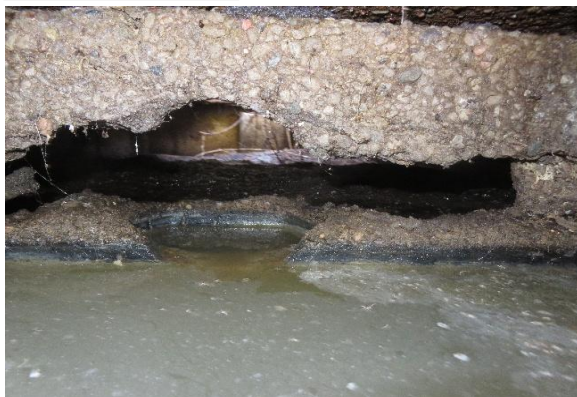
Center baffle

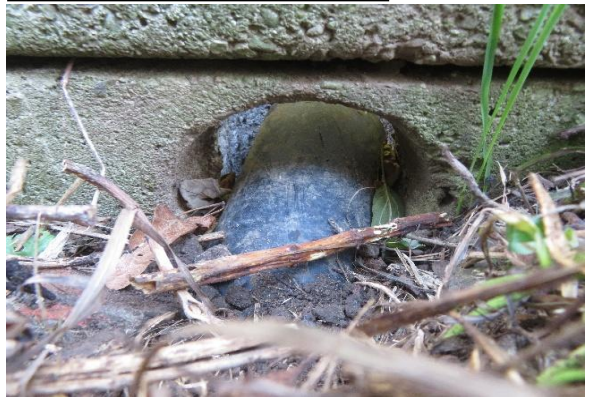
Exposed drain and waste line
