## WETT RECOMMENDED INSPECTION CHECKLIST

| Address:<br><u>7851 Dufferin St #500</u><br><u>Concord, ON</u><br><u>L4K 1R6</u> | Address:<br><u>526 Sandford St</u><br><u>Newmarket, ON</u> |
| Inspector's name: <u>Shawn Jones</u> | WETT No.: <u>10705</u> |

File Reference #: 260825-1

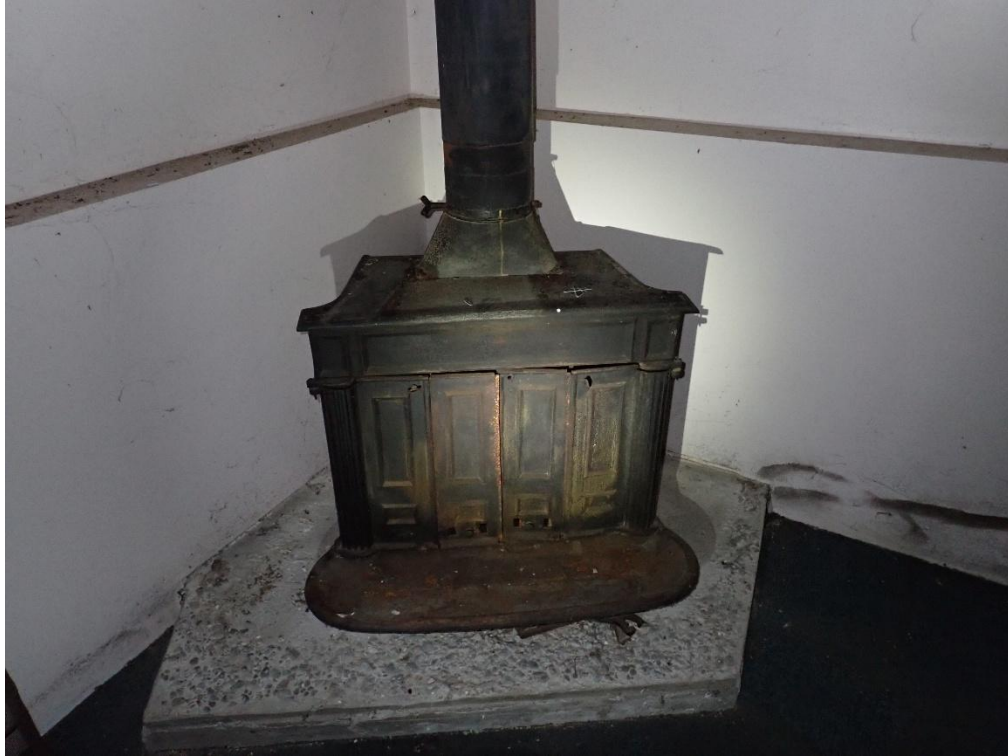
1/2. The uncertified stove does not have the minimum required clearance to combustible materials. This is a fire hazard.

10/12. The ember pad does not meet the minimum extension requirements to the front and right side of the stove.

**526 Sanford St – Basement Woodstove Overview**

The system is not safe for use.

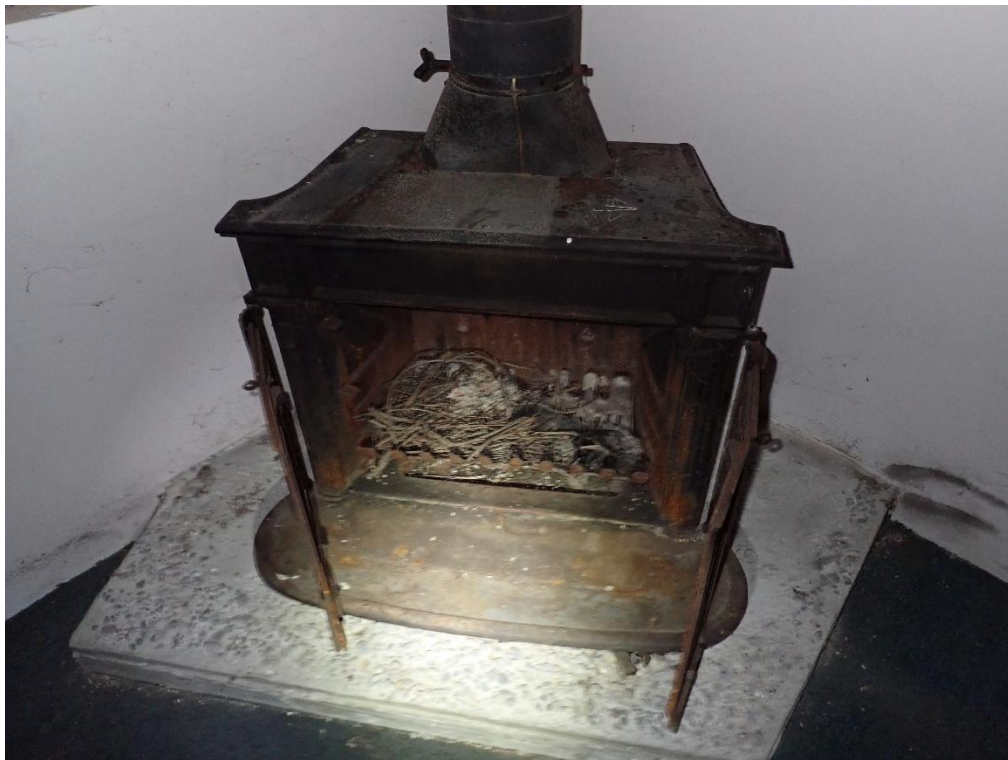
A birds nest was noted inside the firebox. It appears that birds have been able to enter the chimney. A level 2 wet inspection is required to examine the chimney interior for blockages.

**526 Sanford St – Birds Nesting Inside Stove Interior**

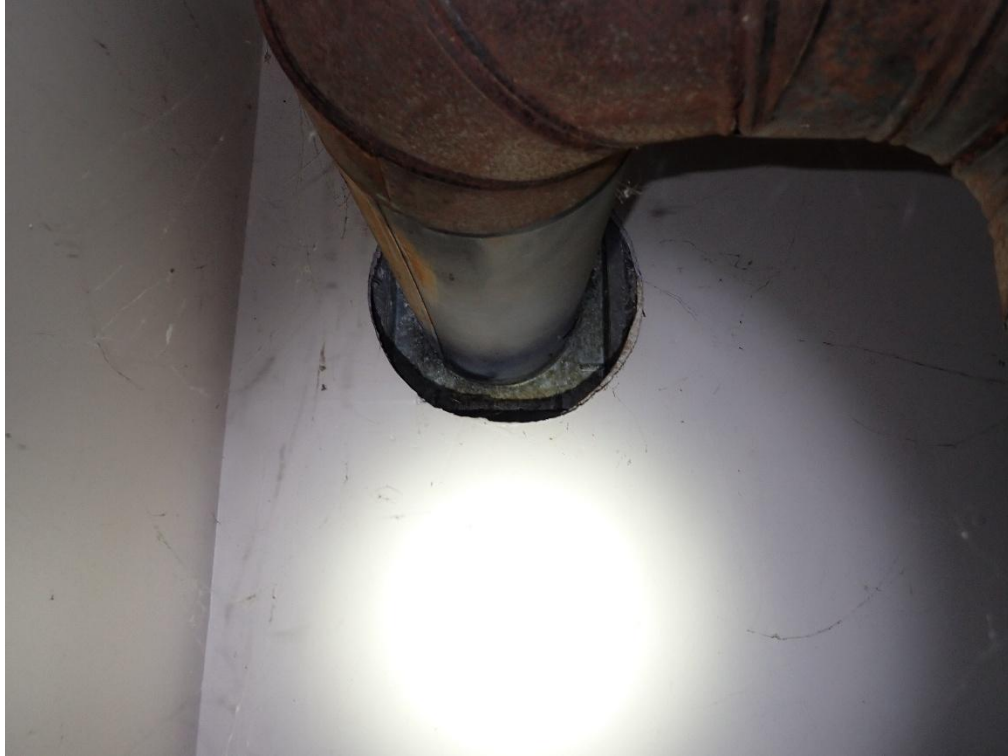
| 18. Clearances | $\geq 18''$ | 1'' | <input type="checkbox"/> N/A | <input type="checkbox"/> Yes | <input checked="" type="checkbox"/> No | <input type="checkbox"/> UTI |

18. The single wall stove pipe does not have adequate clearances to combustible materials. This is a fire hazard.

**526 Sanford St – Inadequate Clearance Between Flue Pipe and Combustible Materials**

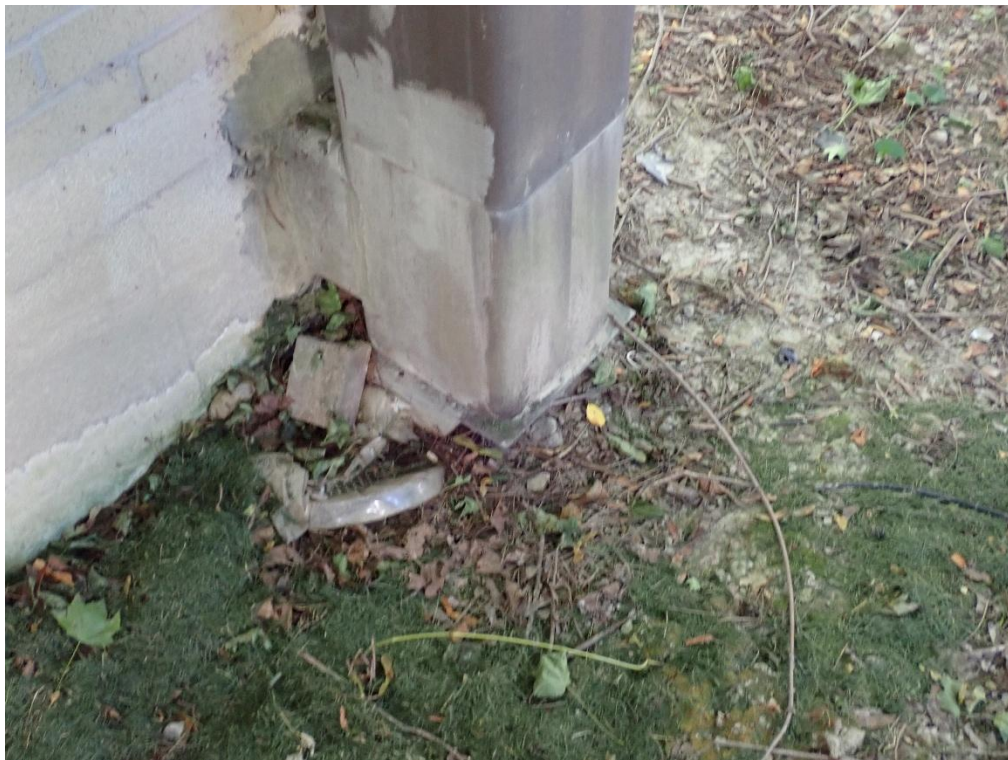
3 The clean out tee does not have the minimum required clearance to allow for clearing of the chimney.

**526 Sanford St – Inadequate Clearance Between Base Tee and Grade**

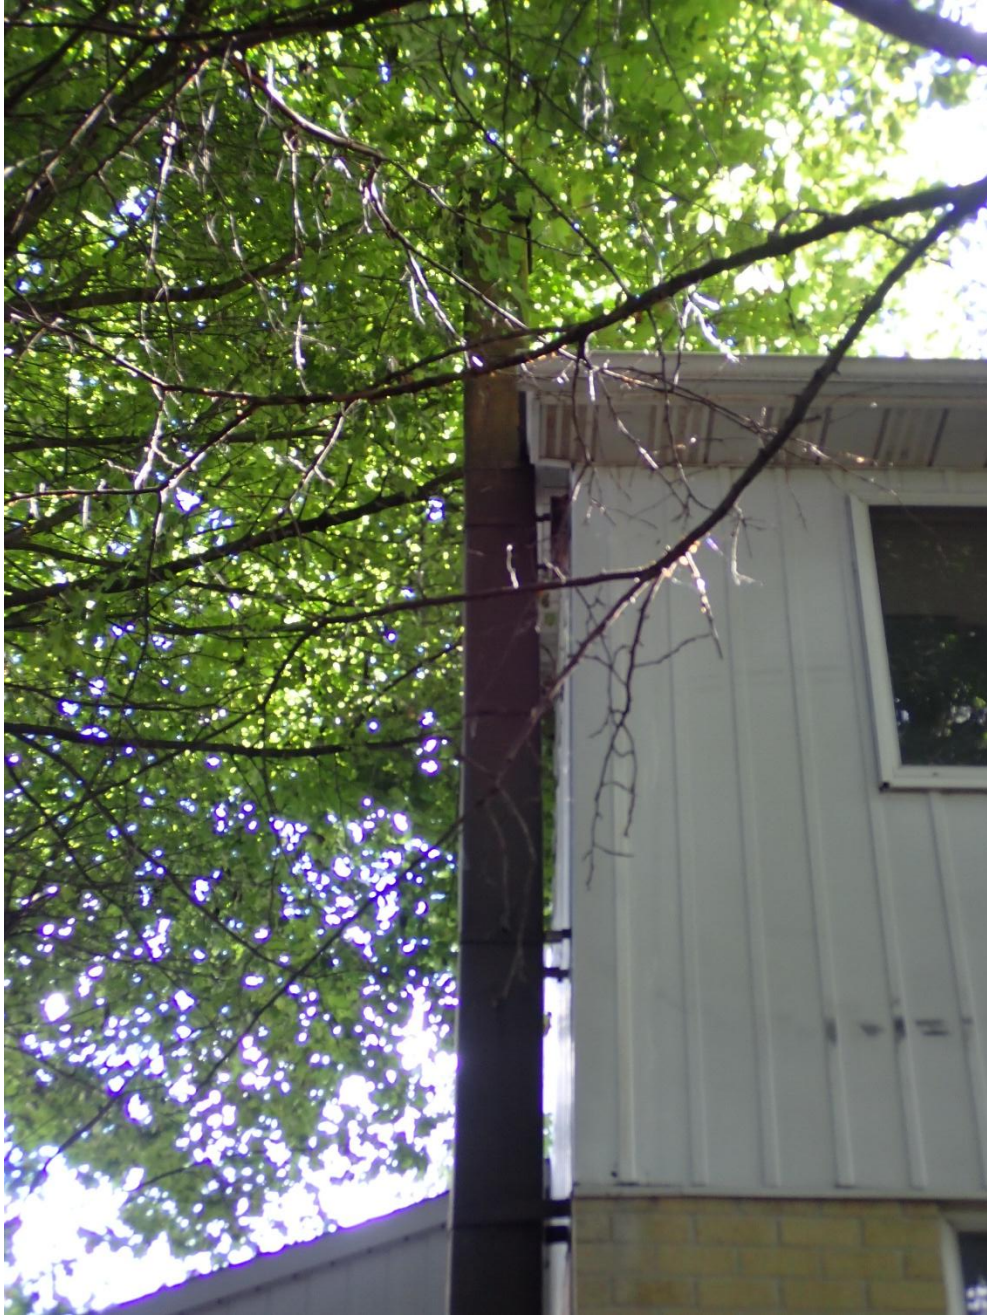
The chimney appears to be leaning. This can result in detachment of the chimney sections resulting in a fire hazard. Further assessment is required.

**526 Sanford St – Leaning Chimney Sections**

The chimney does not appear to be safe for use. A level 2 inspection is required to inspect the interior of the chimney.

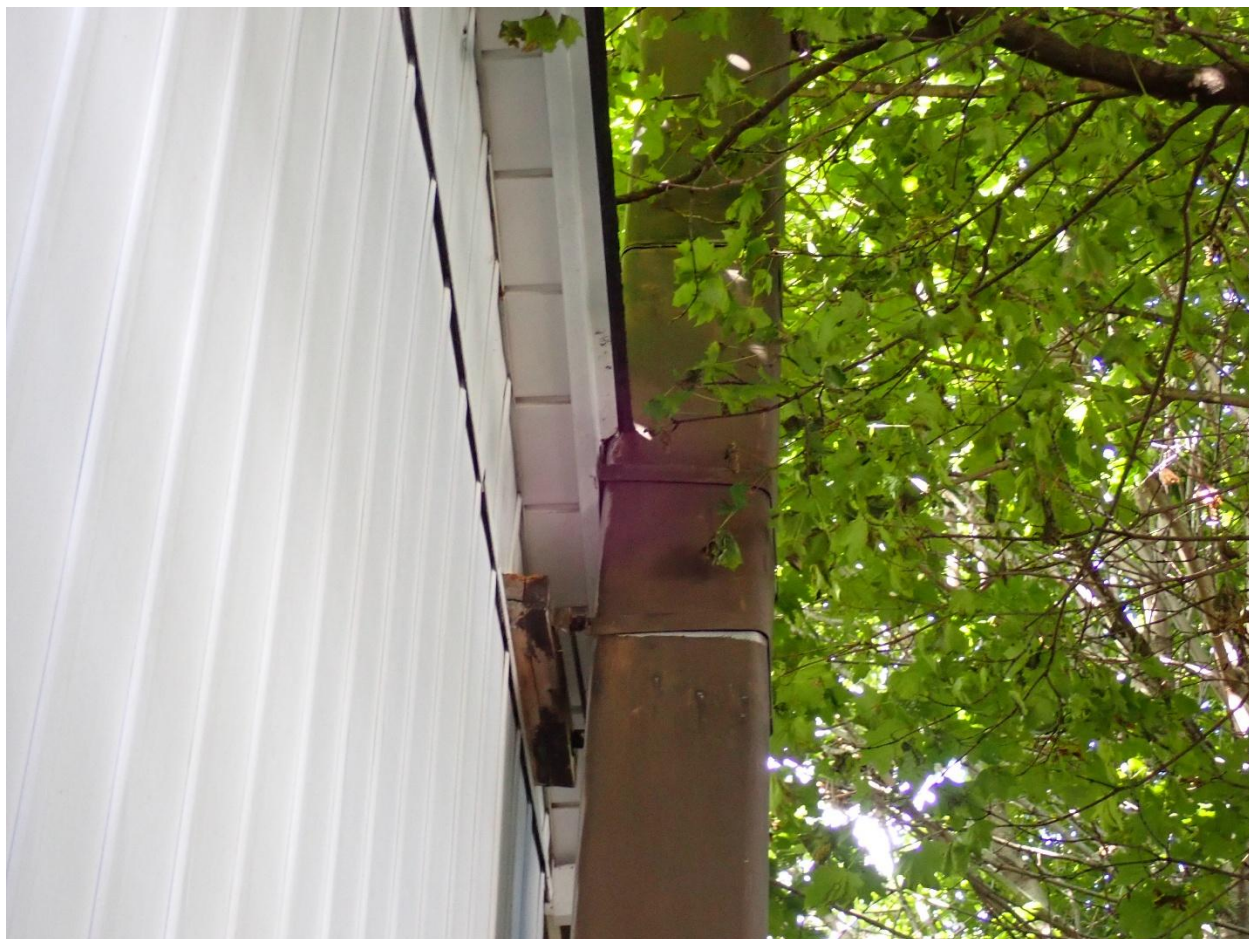
The chimney may not have adequate clearance to combustible materials at the roof eave. Further investigation is required.

**526 Sanford St – Potential Inadequate Clearance To Combustable Materials**
