The following describes the findings of the inspection of the onsite wastewater treatment system at:

Inspected: 1160 County Rd 2 Brockville

Date: August 7, 2025

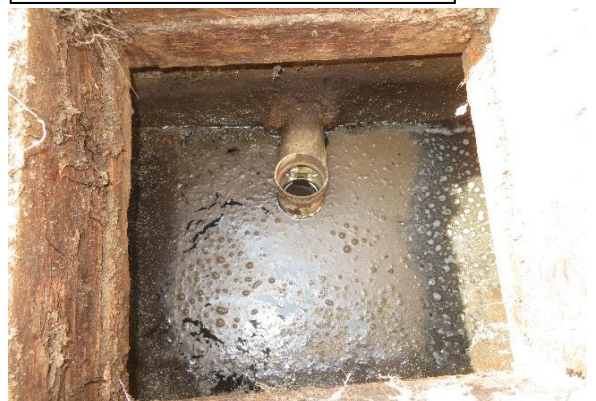
No effluent filter at outlet

- 1 Recommend the installation of an effluent filter to improve the longevity of the absorption area.
- 2 Recommend keeping the absorption area clear of trees and roots, the presence of which can be disruptive to the system.
- 3 Liquid levels in the tank rose 4" during flow test, which may indicate a reduced capacity within absorption area.
- 4 The absorption area was evaluated by flow test only.
- 5 The onsite sewage system was functioning at a marginal capacity at the time of inspection, future longevity can not be predicted.

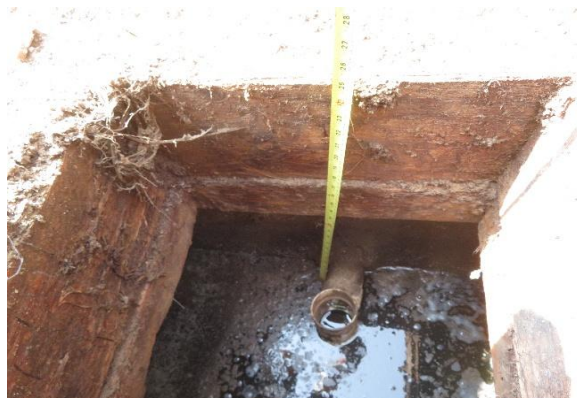
Liquid level before flow test

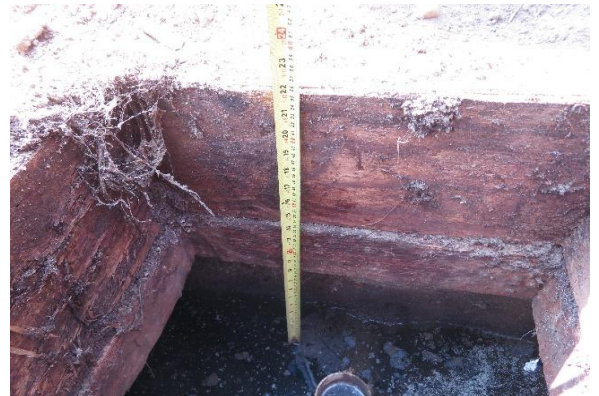
Liquid level after flow test
