Prepared For: Gordon's Ltd

The following describes the findings of the inspection of the onsite wastewater treatment system at:

Inspected: 25 Riverside Drive Kingston

Date: October 21, 2024

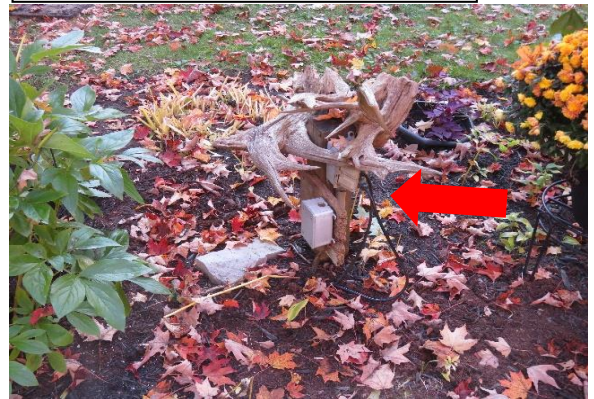
Electrical outlet at pump chamber

- 1 Note: High water alarms for sewage pumps are not functionally tested at the time of inspection.
- 2 Recommend the installation of an effluent filter to improve the longevity of the absorption area.
- 3 Recommend pump chamber is supplied by a GFCI protected outlet with weather proof cover that can be closed when in use.
- 5 Recommend keeping the absorption area clear of trees and roots, the presence of which can be disruptive to the system.
- 6 The absorption area was evaluated by flow test only.
- 7 Flow test results may be more favourable when there has been a lack of regular use.
- 8 The onsite sewage system was functional at the time of inspection, future longevity can not be predicted.

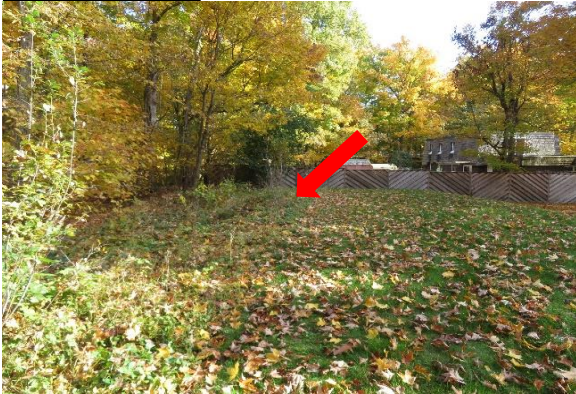
Trees in bed

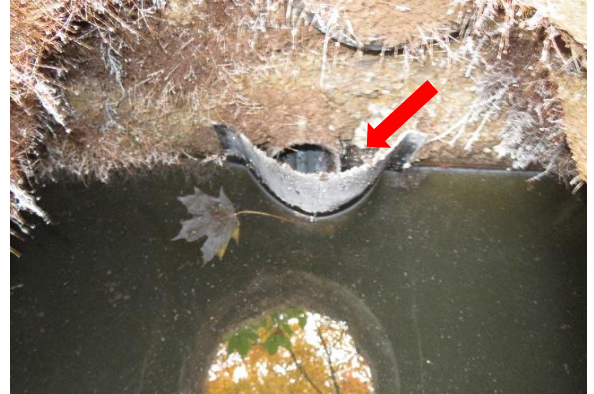
No effluent filter at outlet
