Prepared For: Gordon's Ltd

The following describes the findings of the inspection of the onsite wastewater treatment system at:

Inspected: 1084 Moon Rd Godfrey

Date: August 20, 2025

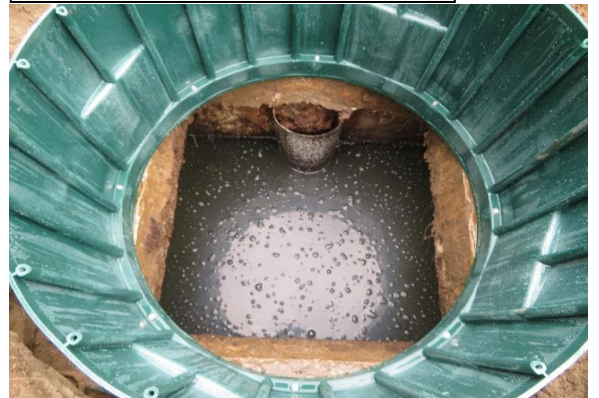
No effluent filter at outlet

- 1 Recommend the installation of an effluent filter to improve the longevity of the absorption area.
- 2 Treatment tank does not contain sufficient accumulated solids to necessitate pumping.
- 3 The absorption area was evaluated by flow test only.
- 4 The onsite sewage system was functional at the time of inspection, future longevity can not be predicted.
