Prepared For: Gordon's Ltd

The following describes the findings of the inspection of the onsite wastewater treatment system at:

Property
 Inspected: 163 Main St Seeleys Bay
 Date: May 8, 2026

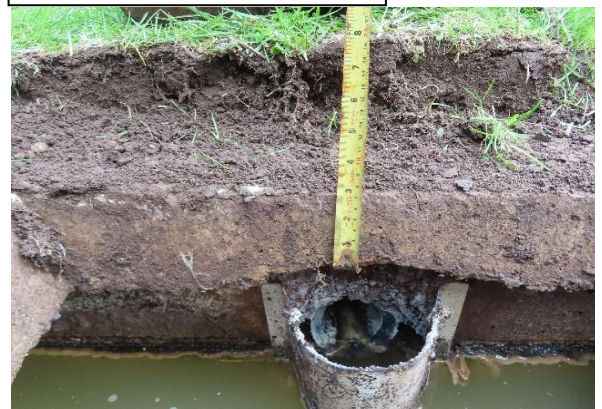
- 1 Water filter discharge was not visible. Recommend water filter discharge is directed away from septic system if necessary, as it places an additional load on the treatment system.
- 2 There is approximately 1" of degraded concrete at outlet. This is not having a negative effect on the system however, it is recommended to monitor this area when servicing.
- 3 Concrete center baffle has some degradation. This is not yet having a negative effect on the system. Recommend monitoring this area when servicing and repair when necessary.
- 4 Outlet baffle is loose. Recommend repair or replacement with effluent filter assembly.
- 5 The absorption area was evaluated by flow test only.
- 6 Flow test results may be more favourable when there has been a lack of regular use.
- 7 The onsite sewage system was functional at the time of inspection, future longevity can not be predicted.

Thickness of concrete at outlet

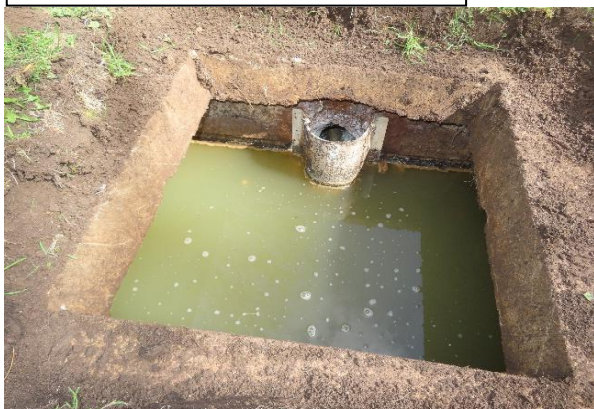
No effluent filter at outlet
