BLAKELY PROPERTY SERVICES

May 1, 2026
File No.: BPS3953

Project Information	
Assessment Type	Sewage System
Property Location	2369 Lookout Drive, Cumberland, Ontario
Dwelling Type (Age)	Single Family Home (1999)
Purpose	Pre-Sale Assessment
Assessment Date	April 30, 2026

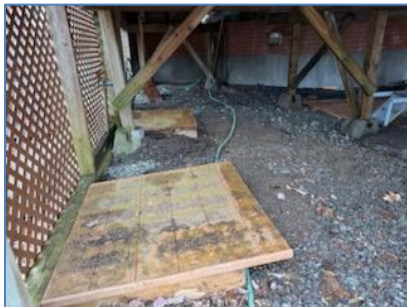
Fig. 1 – Septic Tank Location

The location of the concrete septic tank with respect to the house foundation and drilled well conforms to the present regulations, the Ontario Building Code, 2024 (OBC). The top of the tank is buried approximately 0.15 m below the ground surface. A wood riser and cover assembly, which extends to the ground surface, has been installed over each of the tank lids (2) to allow for routine servicing access.

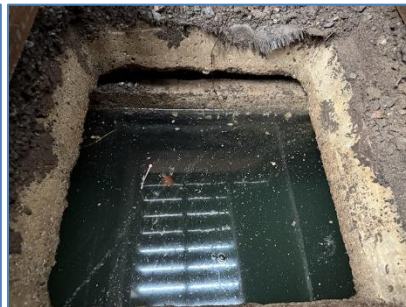
Fig. 2 – Primary Chamber

The access lids to the primary and secondary chambers of the tank were uncovered and opened. Based on a visual inspection, the tank appears to be structurally sound and watertight at the present time. However, deterioration of the concrete was noted on the inside face of the tank walls in the secondary chamber of the tank. The concrete centre wall is presently in good condition. The concrete inlet and outlet baffles are intact and functional at the present time.

- It is recommended that the septic tank be inspected and pumped every three (3) to five (5) years, depending on the applied flow.
- As an upgrade to the existing outlet baffle, it is recommended that an OBC approved effluent filter be installed on the outlet pipe in the septic tank. The filter will reduce the passage of sewage solids into the leaching bed and help to extend the life of the bed. These works may be carried out at the time of the next regular pumping event.

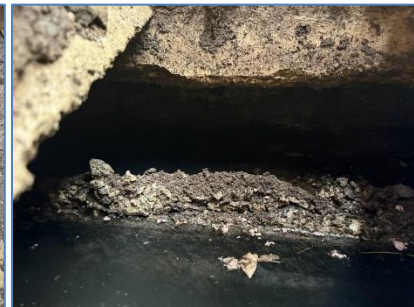
Fig. 3 – Secondary Chamber

It is not known when the septic tank was last pumped. At the time of these works, the liquid in the secondary chamber of the tank was clear of any sewage solids and located at the normal operating level.

- The septic tank is showing signs of age with the deterioration of the concrete on the inside face of the tank walls in the secondary chamber of the tank, above the operating level. However, the tank remains structurally sound at the present time. The tank should be monitored on a regular basis (i.e. tank pump-out frequency) to ensure it remains structurally sound.

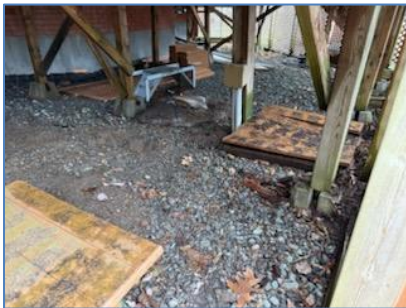
Fig. 4 – Pump Chamber Location

The liquid from the septic tank drains, via gravity, into a concrete pump chamber equipped with an effluent pump, which is used to pump the effluent to the leaching bed. A wood riser and cover assembly, which extends to the ground surface, has been installed over the tank lid to allow for routine servicing access. The risers were observed to be in poor condition. The access lid to the pump chamber was opened.

- The risers over the lid to the pump chamber were observed to be in poor condition.
- The effluent pump was not operational and the discharge assembly from the pump has been disconnected from the forcemain. At the time of these works, the effluent from the pump chamber was slowly draining, via gravity, into the broken forcemain connection.

- It is recommended that the effluent pumping system be serviced and repaired by a qualified service provider. In addition, it is recommended that the service provider ensure the forcemain is clear of any sewage solids/scum between the pump chamber and the leaching bed. Also, it is recommended that the riser assembly over the lid to the pump chamber be replaced.

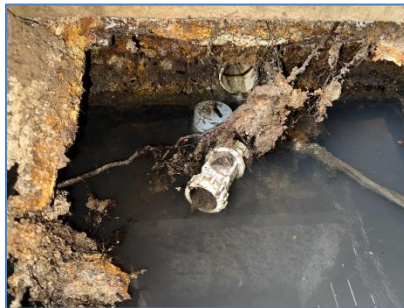
Fig. 5 – Inlet Pipe

Based on a visual inspection, the pump chamber was observed to be structurally sound and watertight. However, deterioration of the concrete was observed on the inner walls of the tank, which is not unexpected for a tank of this age and is not considered to be problematic.

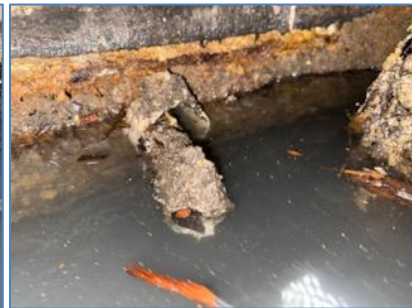
The effluent pump was not operational and the discharge assembly from the pump has been disconnected from the forcemain. At the time of these works, the effluent from the pump chamber was slowly draining, via gravity, into the broken forcemain connection.

Fig. 6 – Liquid Flowing out of Forcemain

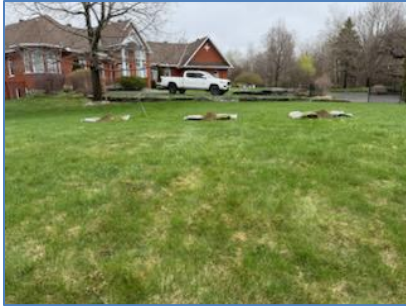
Fig. 7 – Leaching Bed Location

No surficial signs of hydraulic problems associated with the leaching bed were observed. The ground surface over the leaching bed is suitably shaped to shed surface water.

Based on the probe hole results, it appears that the leaching bed consists of a conventional absorption trench style leaching bed containing approximately 120 m of distribution pipe (12 runs of 10 m). The location of the leaching bed with respect to the existing structures and drilled well conforms to the present OBC regulations.

- The leaching bed is functioning adequately from a hydraulic standpoint. However, the bed was not in regular use at the time of these works and any hydraulic problems, if they exist, may not be obvious.

- The leaching bed is approximately 27 years old and the average life expectancy of a bed of this type is approximately 30 years. Usage and maintenance will greatly affect the life expectancy.

- As a means of prolonging the life of the leaching bed, good water practices should be carried out (i.e. prevent overloading the leaching bed by carrying out numerous laundry loads in succession). In addition, the fats, oils and grease should not be discharged into the sewage system.

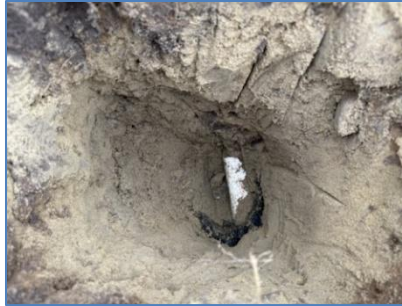
Fig. 8 – Test Hole 1

The depth and quality of the cover materials at each of the test hole locations is considered to be acceptable. A PVC distribution pipe, which is embedded in clear stone, was encountered in each of the test holes located in the leaching bed. At the time of the fieldwork, no evidence of a biomat (black staining) was observed in the clear stone layer or in the underlying sand stratum, which is an indication that the effluent has not been located in these strata for prolonged periods. In addition, no ponded effluent was encountered in the test holes for the total investigated depth. Typically, in a properly functioning leaching bed, the distribution pipes and clear stone layer are unsaturated for the majority of the time, as was observed. However, the leaching bed was not in regular use at the time of these works (i.e. house vacant) and higher liquid levels may occur under normal operating conditions.
