Job #41207

## Septic Inspection

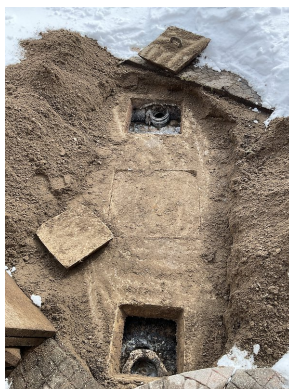
### Manhole(s)

Pass

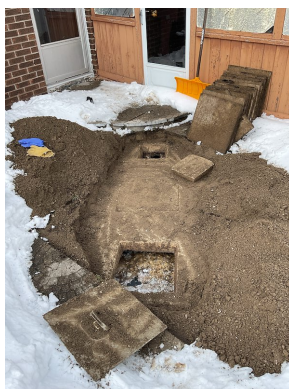
### Accessibility

Pass

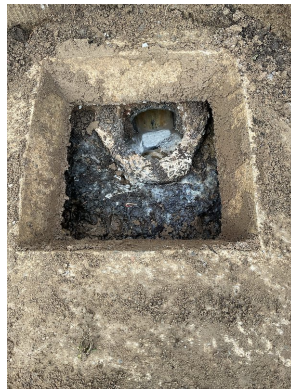
### **Inlet Baffle**

Pass

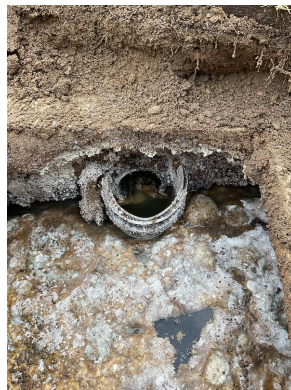
### **Outlet Baffle / Effluent Filter**

Fail

It is recommended that the tank is pumped out. The partition wall is showing signs of deterioration, which is typical of a tank of this age. The outlet baffle has seen a makeshift repair in the past. Replacement is recommended. An affluent filter can be installed in lieu of the outlet baffle, which can help mitigate solid material building up in the leaching field runs

**NOTE - This has been repaired as a result of the inspection. It was repaired by A1 Plumbing on March 2, 2026.**
