Prepared For: Gordon's Ltd

The following describes the findings of the inspection of the onsite wastewater treatment system at:

Inspected: 4820 Huntbach Lane Battersea

Date: April 20, 2026

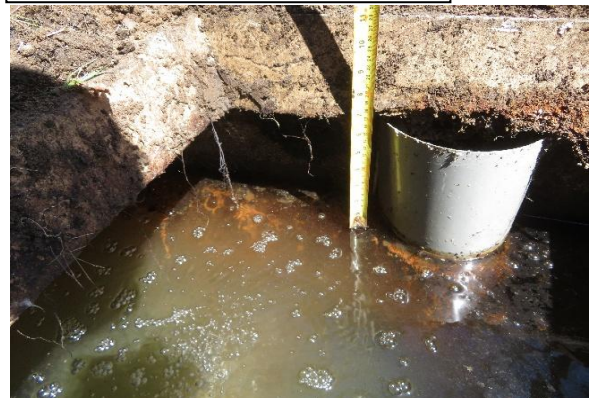
No effluent filter at outlet

- 1 Recommend water filter discharge is directed away from septic system if possible, as it places an additional load on the treatment system.
- 2 Recommend the installation of tank lid risers for ease of use when servicing.
- 3 Recommend the installation of an effluent filter to improve the longevity of the absorption area.
- 4 Recommend keeping the absorption area clear of trees and roots, the presence of which can be disruptive to the system.
- 5 Recommend removing fire pit and that grass is seeded over absorption area to reduce soil erosion and absorption of surface water.
- 6 The absorption area was evaluated by flow test only.
- 7 Flow test results may be more favourable when there has been a lack of regular use.
- 8 The onsite sewage system was functional at the time of inspection, future longevity can not be predicted.

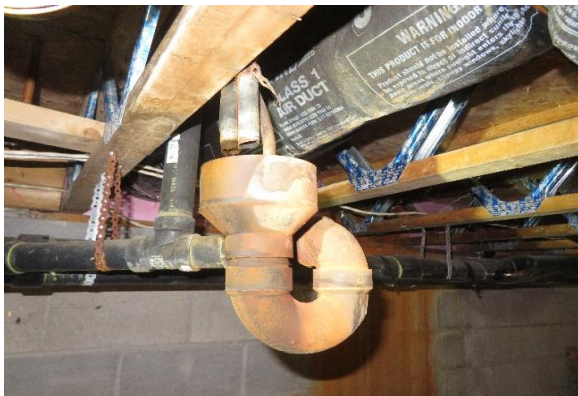
Water filter dischrge

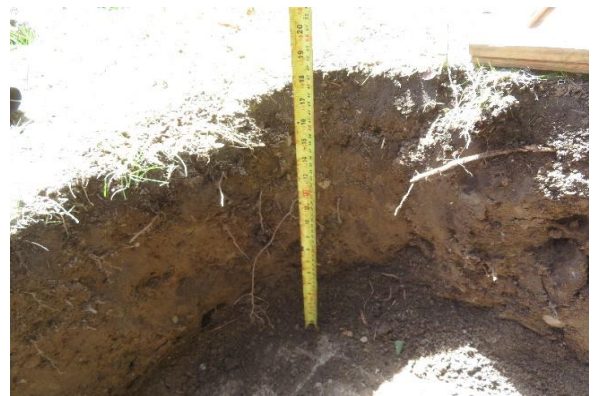
Depth to top of tank
