The following describes the findings of the inspection of the onsite wastewater treatment system at:

Inspected: 101 Hinchinbrooke Rd North Verona

Date: April 13, 2026

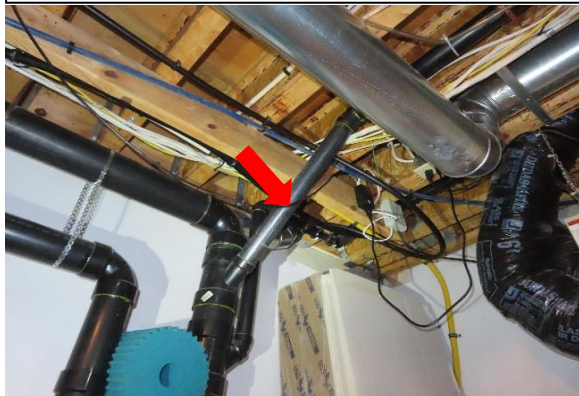
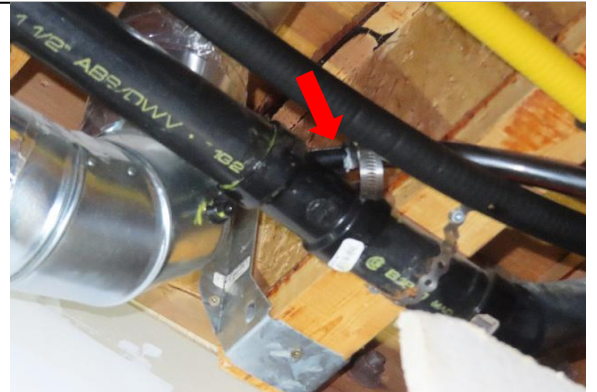
Water filter discharge to septic

- 1 Recommend water filter discharge is directed away from septic system if possible, as it places an additional load on the treatment system.
- 2 The absorption area was evaluated by flow test only.
- 3 The onsite sewage system was functional at the time of inspection, future longevity can not be predicted.
