Inspector: Haroon Choudhry · Certified & Insured · Report ID: ASADS-2026-0127

WETT INSPECTION REPORT

182 Burnhamthorpe Rd

Etobicoke

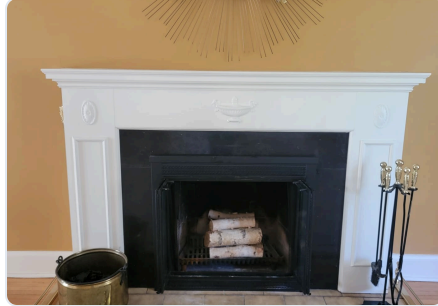
F01 — Main floor fireplace — masonry wood-burning fireplace; appeared compliant

The main floor appliance was identified as a traditional masonry wood-burning fireplace. The firebox is constructed of refractory firebrick on the side and rear walls with a cast iron log grate in place. A brass-and-glass bi-fold door assembly with metal mesh spark curtain is installed across the firebox opening. The white painted wood millwork mantel surround with decorative pilasters appeared to be in good condition.

Main floor fireplace — full view of firebox opening, millwork surround, and hearth

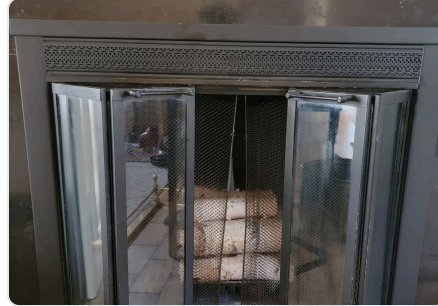
Main floor masonry fireplace close-up — bi-fold glass doors, metal mesh curtain, refractory firebox

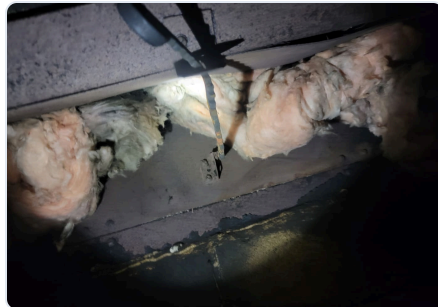
F02 — Basement fireplace — masonry wood-burning fireplace; visual assessment restricted

The basement appliance was identified as a masonry wood-burning fireplace. A full Level 1 assessment could not be completed due to the smoke chamber/flue throat being blocked with fibreglass insulation (documented in the Damper & Controls section). The firebox interior and smoke chamber conditions could not be fully evaluated. A Level 2 inspection including a video scan of the flue and full internal assessment is required before the appliance can be assessed for compliance.

Basement fireplace smoke chamber — fibreglass insulation stuffed into throat/hatch opening

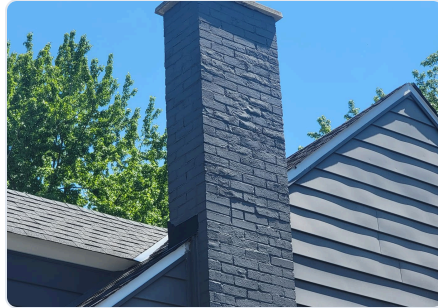
F03 — Exterior masonry chimney — appeared intact from grade; cap present

The exterior masonry chimney, clad in dark stacked-stone siding consistent with the building exterior, was observed from grade level. The chimney structure appeared intact with no visible major spalling, displacement, or structural failure. A metal single-flue cap was observed at the crown, providing rain and debris protection. Flashing at the roof-to-chimney junction, mortar joint condition, and spark arrestor status could not be fully assessed from grade level.

Exterior masonry chimney — stone cladding, metal cap at crown, appears intact from grade

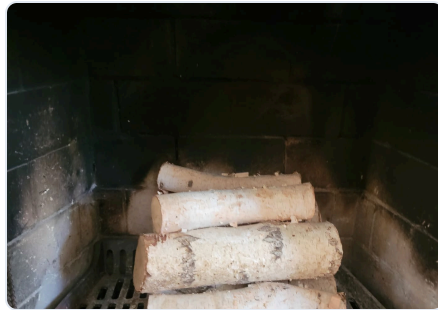
Main floor firebox interior — light sooting on refractory firebrick, normal use condition

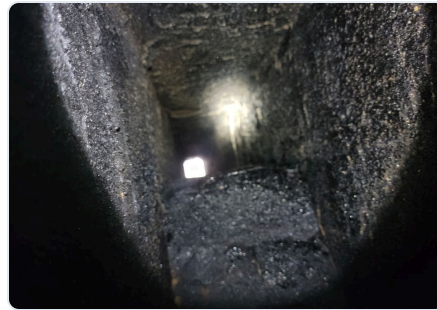
F04 — Main floor flue — low creosote level; flue open and unobstructed

The main floor fireplace flue was inspected from the firebox opening and via a flue view. The flue interior walls showed a low level of creosote accumulation consistent with normal use and within acceptable limits. The firebox refractory firebrick walls showed light sooting. The flue appeared open and unobstructed with no evidence of significant buildup, blockage, or liner deterioration. The flue is considered compliant for continued operation.

Main floor flue interior — low creosote level, flue open and unobstructed

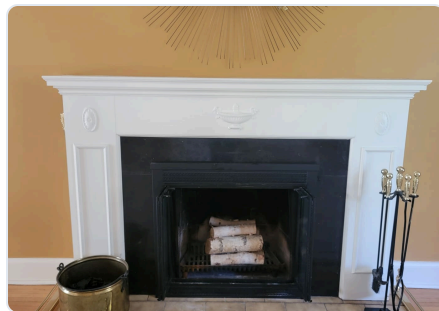
F08 — Main floor fireplace — ceramic tile hearth extension present and appeared adequate

A ceramic tile hearth extension was observed in front of the main floor fireplace opening. The tile surface appeared to be in good condition with no visible cracking or displacement. The hearth extension appeared to provide adequate floor protection for the appliance type.

Main floor fireplace — ceramic tile hearth extension visible at base of firebox

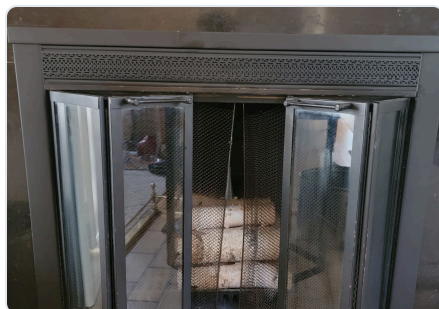
F10 — Main floor fireplace — bi-fold glass door assembly with mesh curtain; appeared functional

The main floor fireplace was equipped with a brass-framed bi-fold glass door assembly with a metal mesh spark curtain. The doors appeared to be intact, operable, and in good condition. The door assembly provides the primary means of controlling combustion air supply and preventing spark and ember emission when the fireplace is in use.

Main floor fireplace — bi-fold glass doors and metal mesh curtain in place

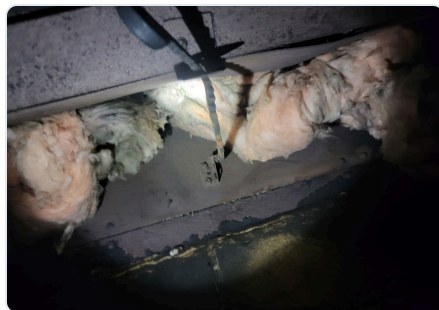
F11 — Basement fireplace — smoke chamber/flue throat stuffed with fibreglass insulation; damper not operable

The smoke chamber and flue throat area of the basement fireplace were found to be packed with fibreglass batt insulation. The insulation had been manually installed — it is not a manufactured or rated component of the appliance. The insulation effectively blocks the flue path and obstructs the damper mechanism, which was visible behind the insulation but could not be operated or assessed.

Fibreglass insulation is not rated for the temperatures generated in a fireplace flue or smoke chamber. If the fireplace were operated with insulation in place: - Smoke and carbon monoxide would back-draft into the living space - The insulation could ignite, causing a structural fire - The damper cannot open to provide proper draft

This installation does not meet the requirements of CSA B365 or NFPA 211 and constitutes an immediate safety hazard. Dark staining observed on portions of the insulation may indicate the fireplace has been used while the insulation was present.

Basement smoke chamber/throat — fibreglass insulation packed into opening, damper obscured

→ Do not operate the basement fireplace under any circumstances until a WETT-certified technician removes the insulation, inspects the smoke chamber and damper, and completes a Level 2 inspection including video flue scan.

Estimated cost: **Included in Level 2 inspection scope**
