Prepared For: Gordon's Ltd

The following describes the findings of the inspection of the onsite wastewater treatment system at:

Inspected: 3770 Fairgrounds Rd Inverary

Date: May 24, 2026

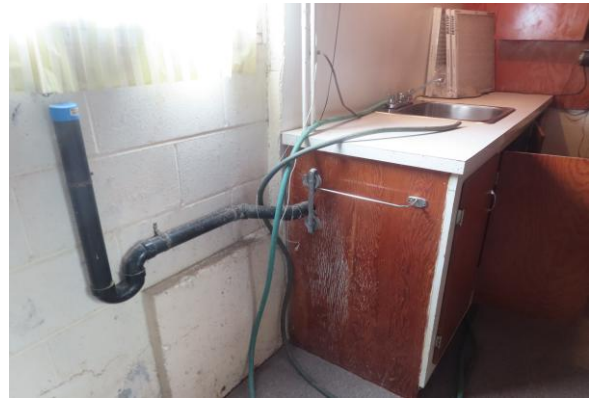
Grey water separated

- 1 Basement sink is separated from the septic system. Recommend providing connection to septic or other treatment system.
- 2 Recommend the installation of an effluent filter to improve the longevity of the absorption area.
- 3 The absorption area was evaluated by flow test only.
- 4 Flow test results may be more favourable when there has been a lack of regular use.
- 5 The onsite sewage system was functional at the time of inspection, future longevity can not be predicted.

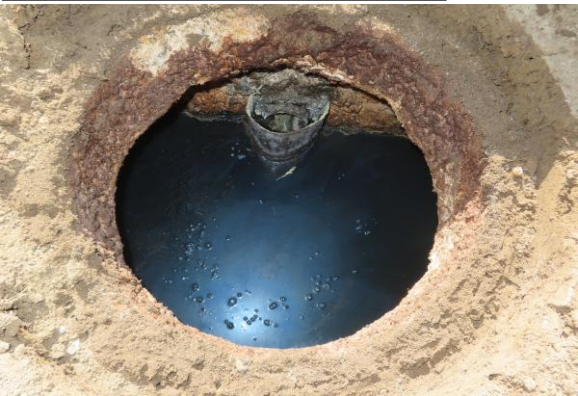
No effluent filter at outlet
