Job #45069

## Septic Inspection

Gordon's Real Estate Brokerage Ltd.  
225 Fish Lake Road  
Demorestville, ON K0K 1W0 Canada

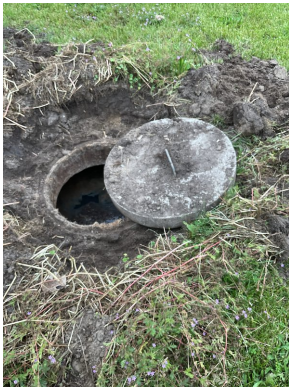
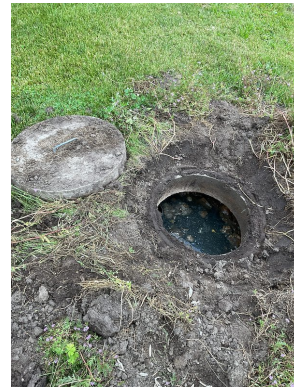
### Manhole(s)

Pass

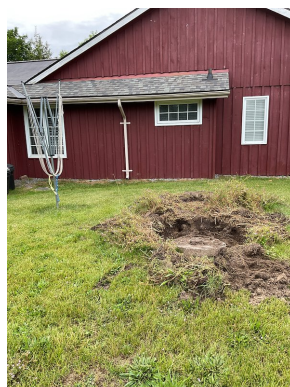
### Accessibility

Pass

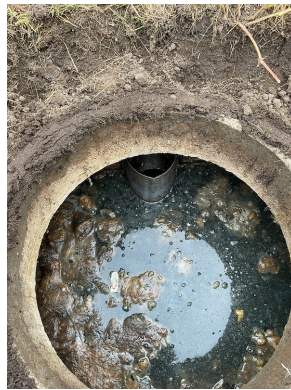
### **Inlet Baffle**

Pass

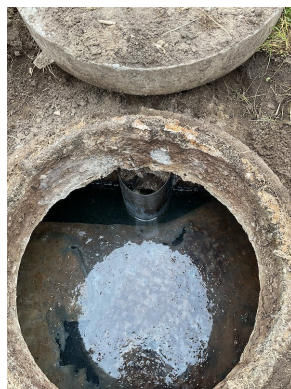
### **Outlet Baffle / Effluent Filter**

Pass

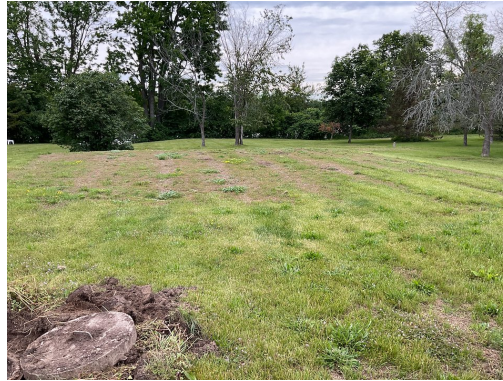
**Leaching Field**

Pass
