Job #45069

Well & Pump Inspection

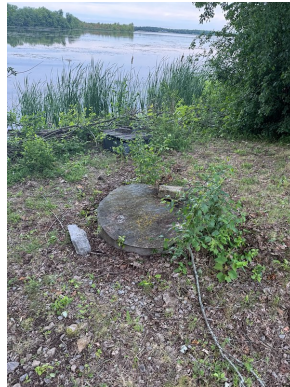
Shore Well

Well was pumped at 5GPM x 20 mins and static fell only a couple inches (good flow). Dependent on lake (shore well).

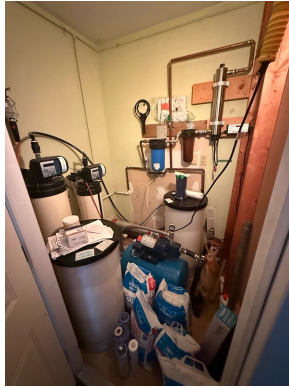
The single line jet pump delivered consistent flow to household fixtures. Pump and tank seemed in good shape. Should have connections looked over as silicone was applied to some threaded joints.

Due to the age and condition of the water treatment we advise the new owner to plan for replacement of some water treatment (softener, filters, UV). Budget dependent on water quality analysis (can book at request).
