Prepared For: Gordon's Ltd

The following describes the findings of the inspection of the onsite wastewater treatment system at:

Inspected: 2950 Route 29 Rd Rideau Lakes

Date: July 23, 2026

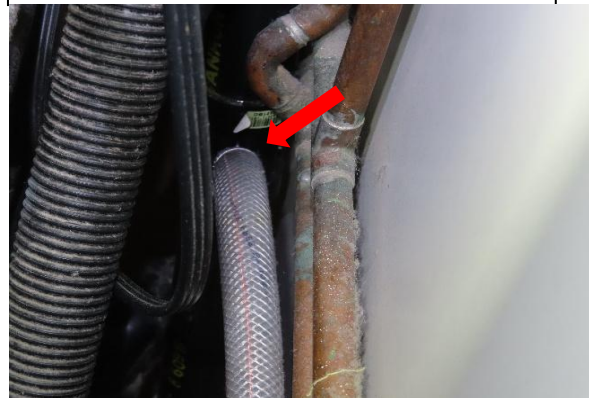
Water filter discharge to septic

- 1 Recommend water filter discharge is directed away from septic system if possible, as it places an additional load on the treatment system.
- 2 Recommend that the effluent filter is cleaned and reinstalled or replaced by a qualified contractor when pumping or when necessary, due to partial clogging and as part of regular maintenance.
- 3 The absorption area was evaluated by flow test only.
- 4 Flow test results may be more favourable when there has been a lack of regular use.
- 5 The onsite sewage system was functional at the time of inspection, future longevity can not be predicted.

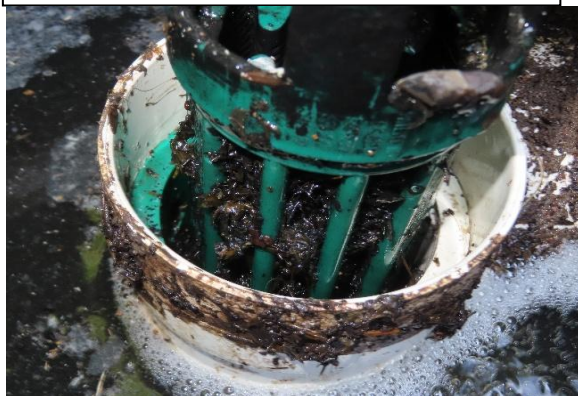
Partially clogged effluent filter at outlet
