# Operation and Maintenance Inspection Report

## Class IV/V Residential Sewage Treatment Systems

| <b>Customer Name:</b><br>Gordons Real Estate Brokerage | <b>Address:</b><br>967 Denridge Rd | <b>Town:</b><br>Selby, ON |

### Sewer line, treatment unit, pump chamber, distribution system, and dispersal bed.

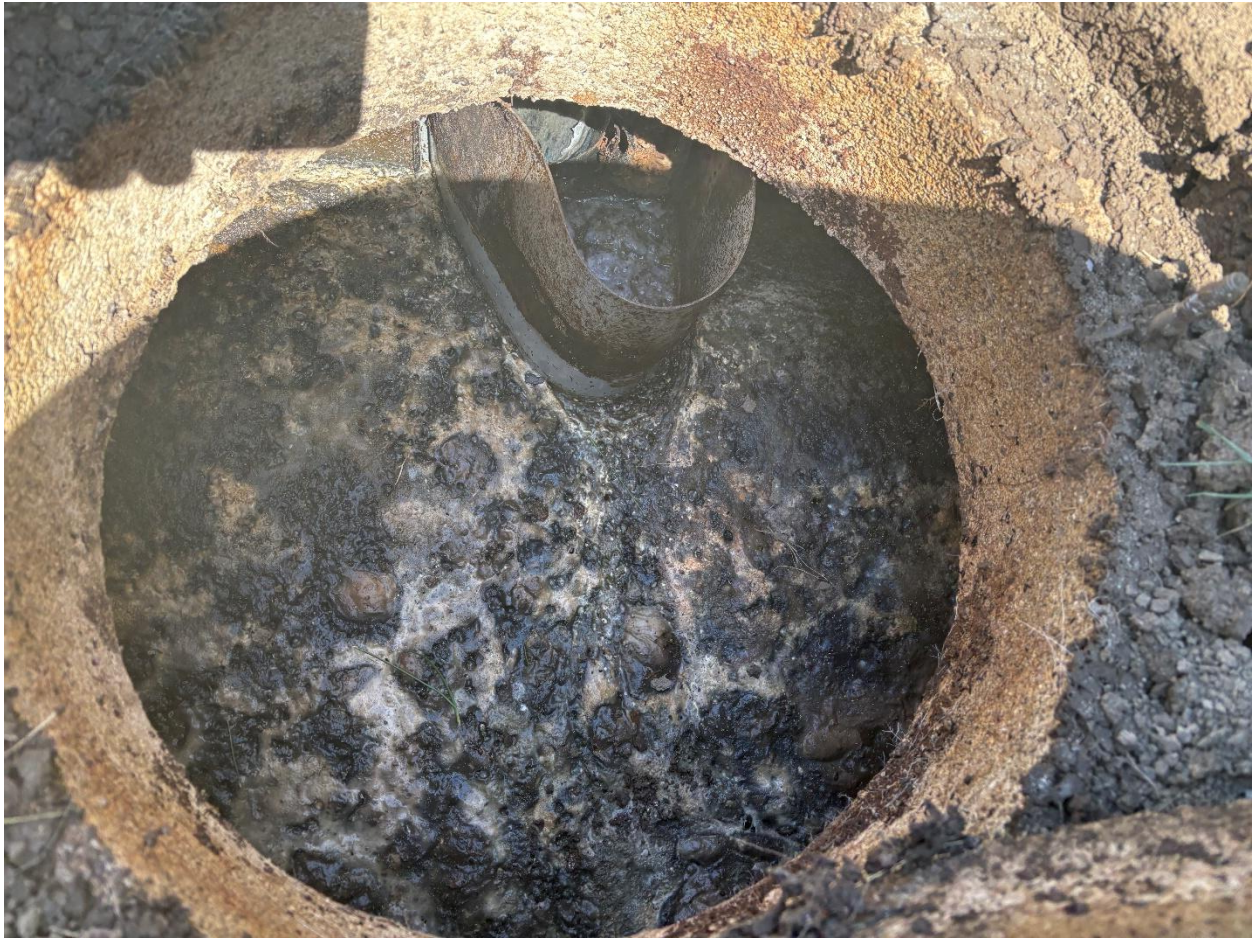
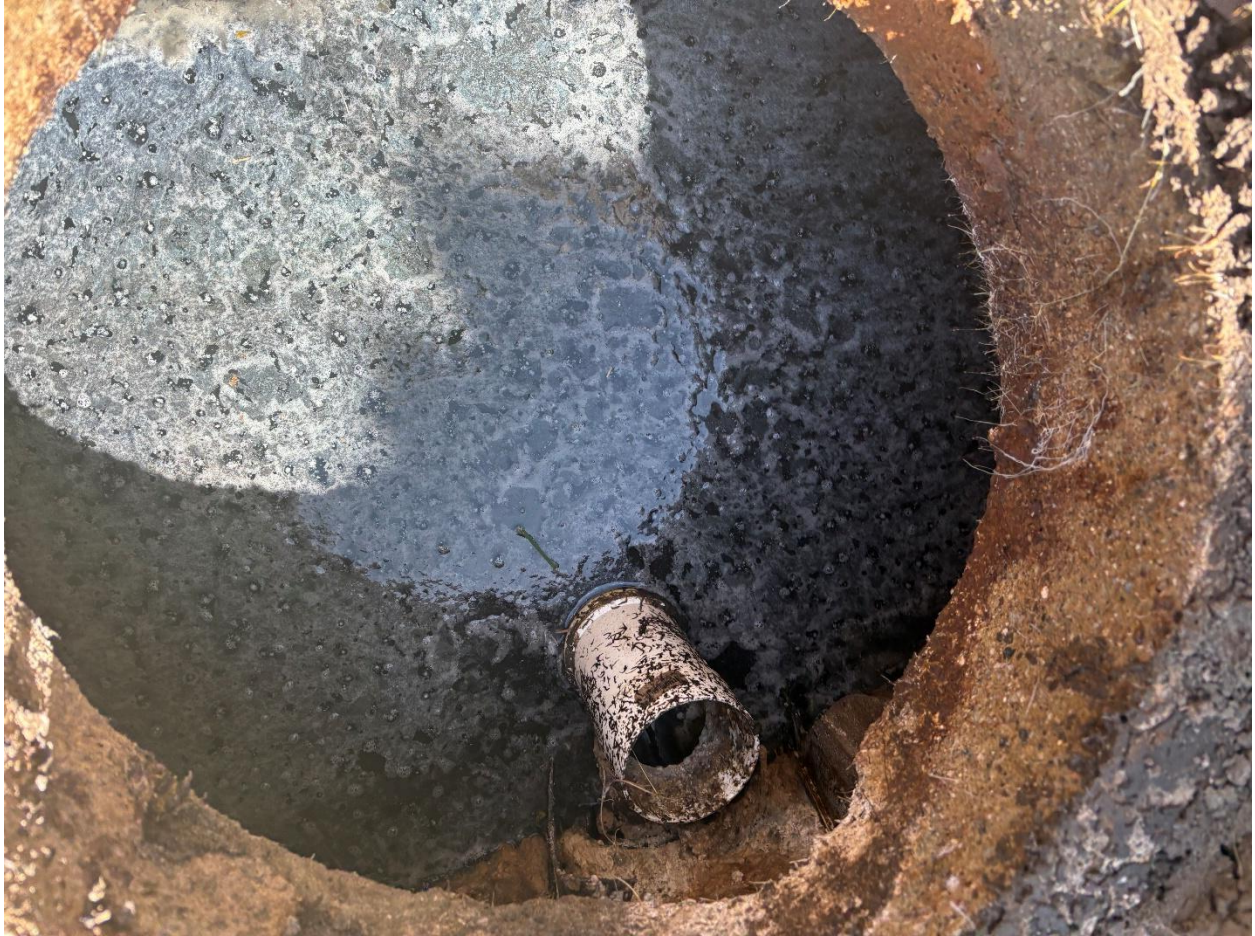
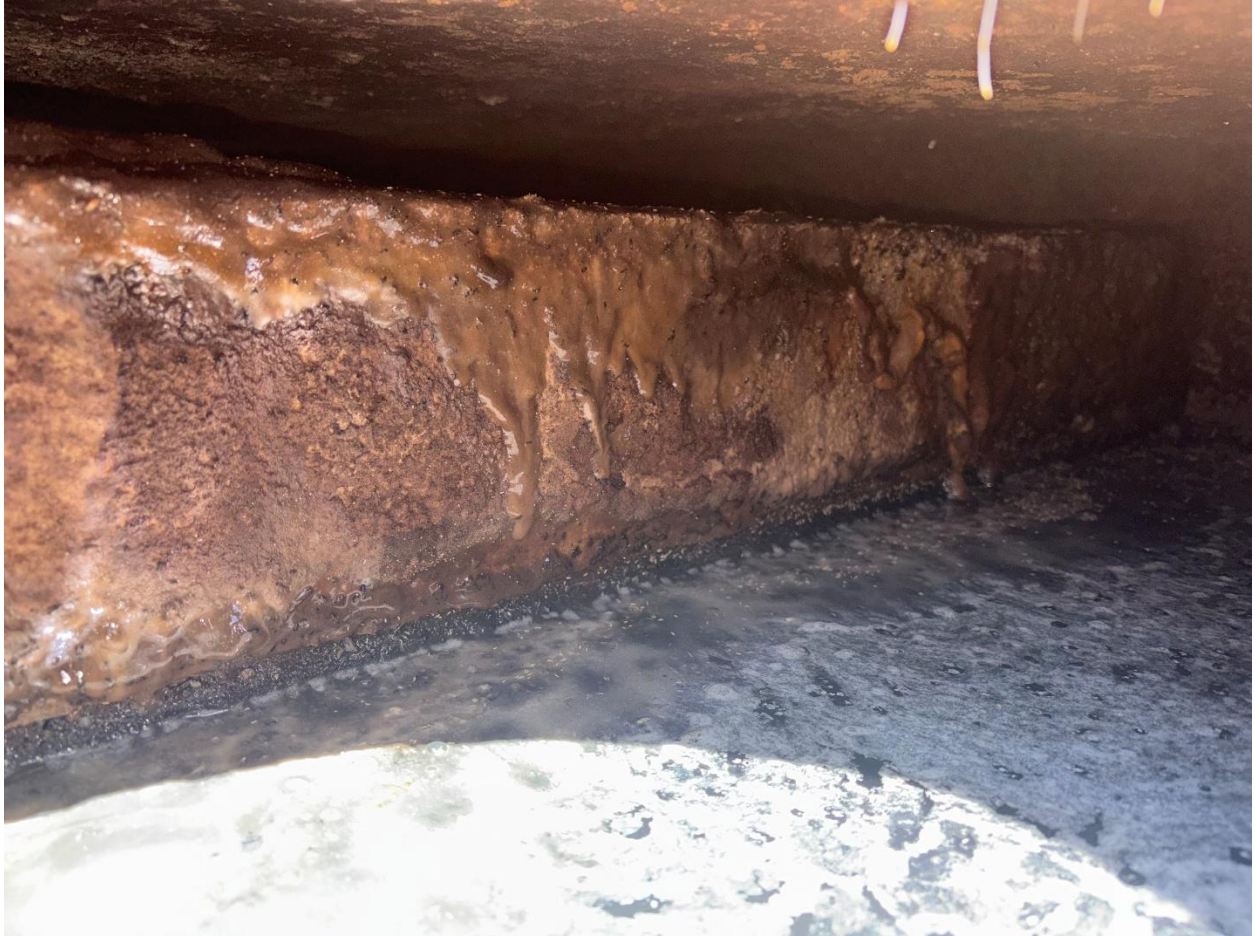
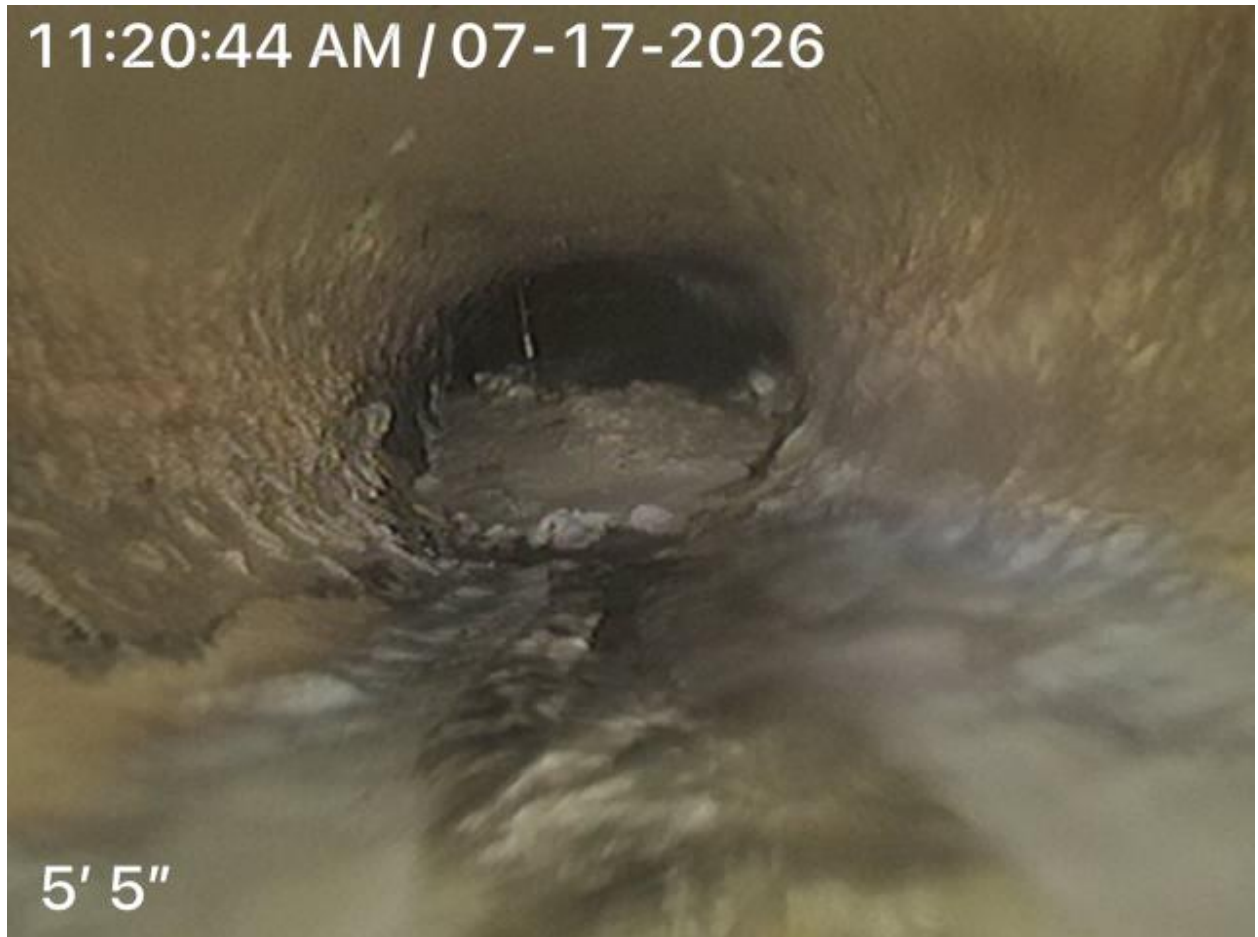
Photographs:

Concrete 2 chamber tank in good condition. Inlet & outlet baffles installed. Interior chamber partition wall in good condition. Flow test showed no restriction of conveyance of sewage between dwelling and tank. Camera inspection of inlet line showed 1 minor pipe bulge, but it did not appear to restrict the flow of sewage from dwelling to tank. Hydraulic load test passed with no noticeable elevation of effluent level in dispersal field. Outlet line camera inspection showed 1 vertical deflection/sag in outlet line immediately after tank. Remainder of outlet line showed no deficiencies.
