| <b>Date Inspected:</b> | September 9, 2026 | | |
| <b>Appliance</b> | Factory-Built Fireplace | | |

| <b>Appliance</b> | Wood Stove and Flue Pipe | | |

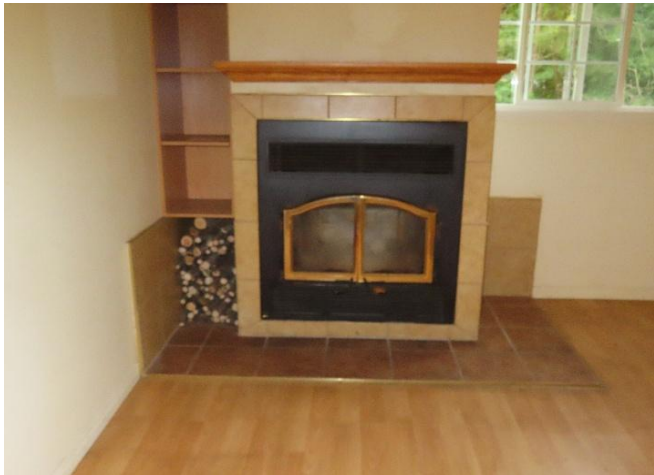
| Improvement is needed to clearances to hearth size at the front (18") is required in order to meet the current standard, and in accordance with the manufacturer's installation instructions. | | | |

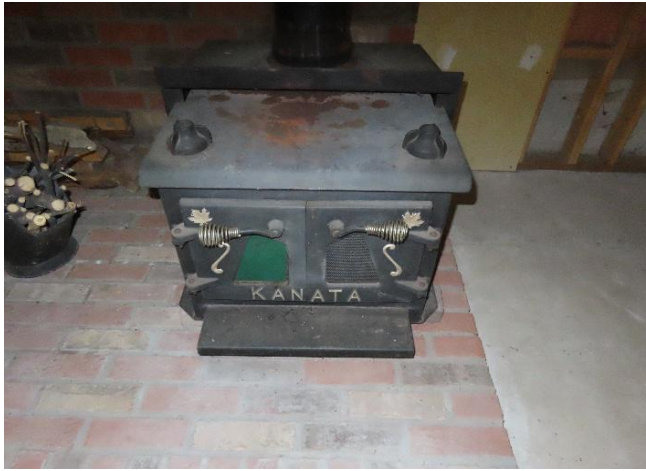
| Improvement is needed to clearances to combustible rear wall in order to meet the current standard. | | | |
| Improvement is needed to flue pipe (mixed types not intended to be used together) in order to meet the current standard. | | | |
| Improvement is needed to flue pipe (missing fasteners) in order to meet the current standard. | | | |
| Improvement is needed to flue pipe (incorrect orientation) in order to meet the current standard. | | | |
| Improvement is needed to door (missing glass at door with an open air space) in order to meet the current standard. Replace prior to use. | | | |
