Job #48056

## Septic Inspection

Gordon's Real Estate Brokerage Ltd.  
1542 Moneymore Road  
Tweed, ON K0K 2Y0 Canada

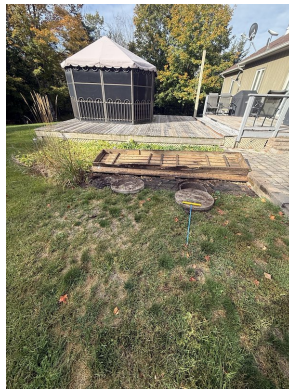
### Tank Type

Concrete

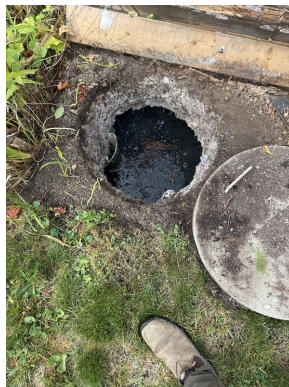
### Manhole(s)

Flag

All flags identified in this report relate to the same underlying issue: significant deterioration of the concrete on the outlet side of the septic tank.

The deterioration is most evident around the outlet side of the tank, including the area where the manhole and riser meet to create a seal, the concrete riser sections between the manhole and tank, and the outlet portion of the tank itself.

However, given the extent of the concrete deterioration and the likelihood that it will continue to progress, we recommend planning for replacement of the septic tank in the near future. This is a tank only replacement on the existing field. We would recommend replacing the existing concrete tank with an appropriately sized plastic tank to reduce the likelihood of similar deterioration occurring in the future.

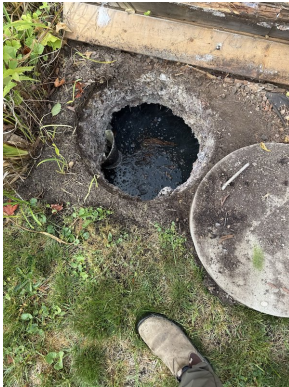
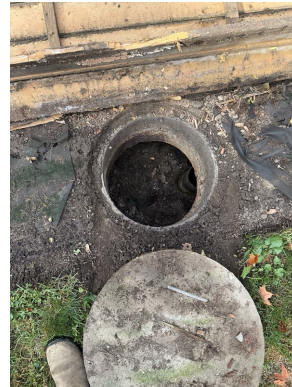
## Lid

Flag

The system is approximately 20 years old. However, a combination of gases associated with the septic system and well water conditions appears to have accelerated deterioration of the concrete. This is particularly noticeable when comparing the condition of the inlet access with the outlet access, as shown in the photos included in this report.

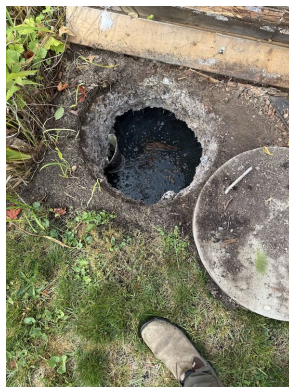
## Outlet Baffle / Effluent Filter

Flag

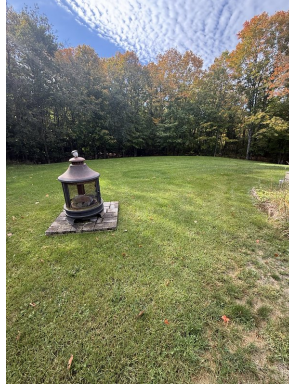
## Leaching Field

Pass

At the time of inspection, the septic system is functional and the leaching field shows no signs of failure.
