The following describes the findings of the inspection of the onsite wastewater treatment system at:

Inspected: 1717 Bay Rd Kingston

Date: April 22, 2026

The following pictures accompany the report of findings for the inspection of the onsite wastewater treatment system at:

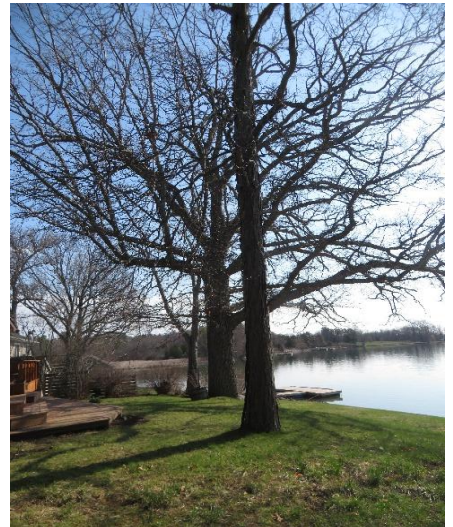
General tree location

- 1 Recommend keeping the absorption area clear of trees and roots, the presence of which can be disruptive to the system.
- 2 Possible grey water separation was observed at the sump pit. Recommend further evaluation and correction if necessary.

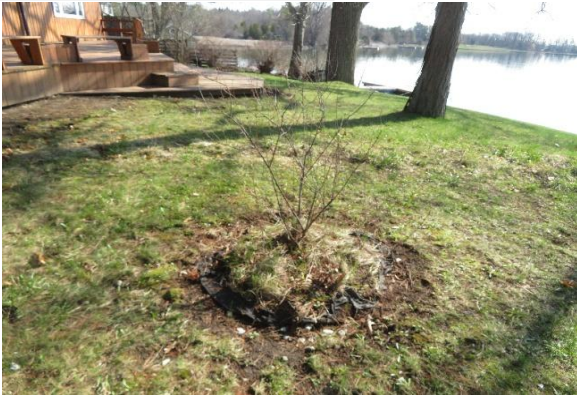
General tree location

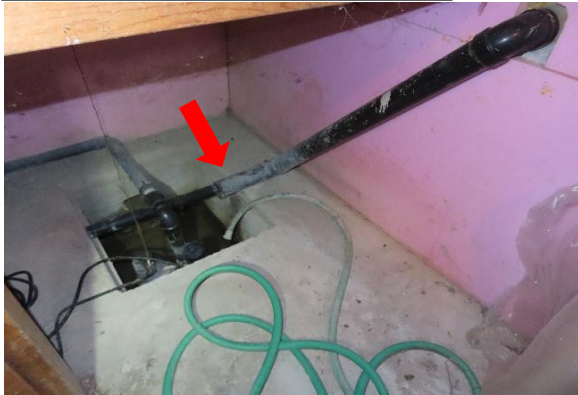
Possible grey water separation

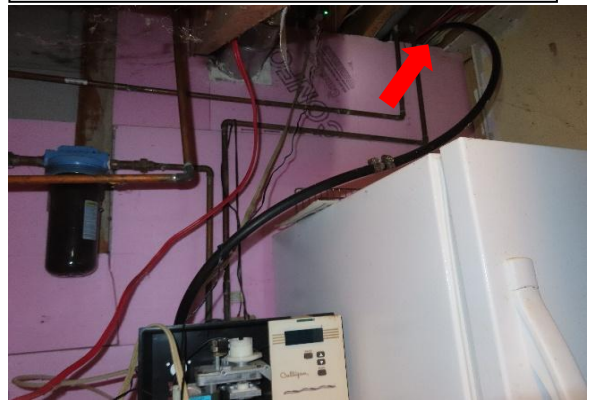
Water filter discharge

- 3 Water filter discharge was not visible. Recommend water filter discharge is directed away from septic system if necessary, as it places an additional load on the treatment system.
